Medicine Lodge Creek

Medicine Lodge Creek TMDL Implementation

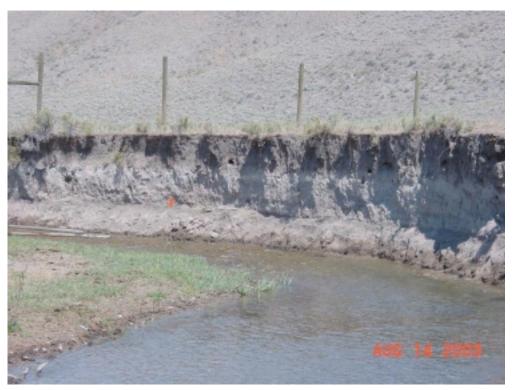
FIGURE 3 Problems that are routinely found along Medicine Lodge Creek include unstable, steep stream banks caused by improper grazing techniques. This problem has been exacerbated by unusual weather patterns over recent years.

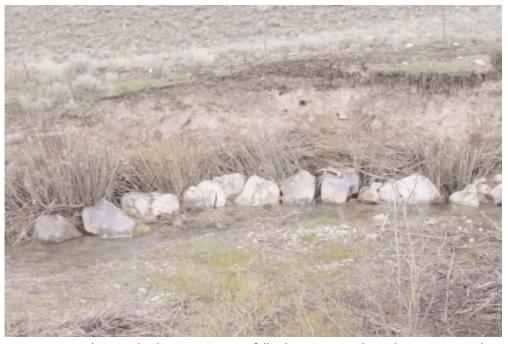
FIGURE 4 One solution to bank erosion is to carefully place rip-rap and woody vegetation at the toe of the bank. With time, this bank will become completely vegetated and stabilized.

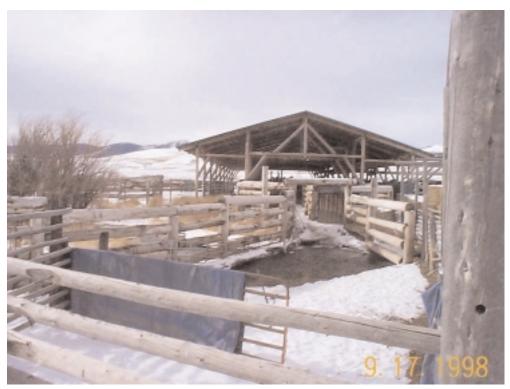
FIGURE 5 Confined Animal Feeding Operation relocated away from Irving Creek

Another common problem along Medicine Lodge Creek is that confined animal feeding operations (CAFOs) have historically been placed in and adjacent to streams in order to provide water for livestock. The CAFO seen in Photo 4 used to be located in Irving Creek. This facility was recently relocated away from Irving Creek and now has water piped into it.

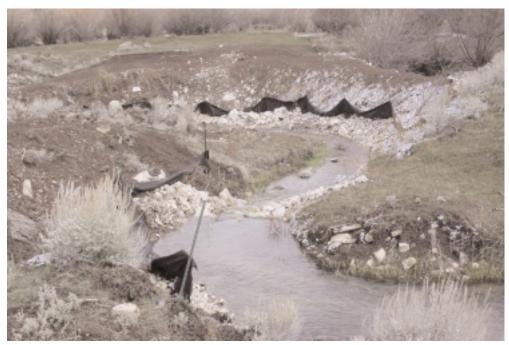
FIGURE 6 Vertical slopes from overgrazing were knocked down. Rip-rap and willows were added to stabilize the bank. This looks unsightly now but will appear quite natural after one or two growing seasons. The biodegradable silt fencing will break down.

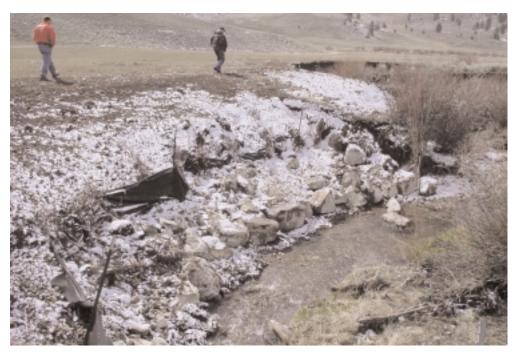
FIGURE 7 The stream bank in the foreground has been re-sloped, stabilized with rip-rap, and replanted. The vertical stream bank in the background has not yet been rehabilitated.

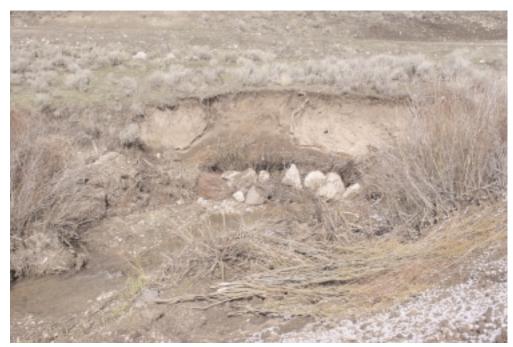
FIGURE 8 Willows were planted as horizontal bundles and as transplanted rooted clumps. All woody plants are locally derived. Many of the vertical banks were stabilized at their toe with large rocks and woody plants. The upper bank will slough back until stabilization is naturally achieved. Vegetation will then continue to establish itself naturally.

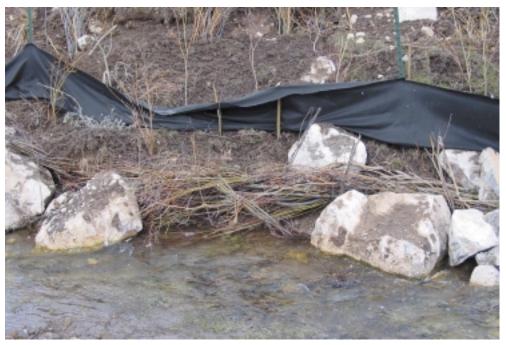
FIGURE 10 A

These willow cuttings were planted with the assistance of water jet injection. Each vegetative revetment consists of several large trees, carefully embedded along the stream banks, to create a slower moving stream velocity where previously faster moving water was causing erosion. By cutting select trees on nearby forest service land, an additional benefit is gained: thinning the trees and reducing the fire danger in the adjacent forest.

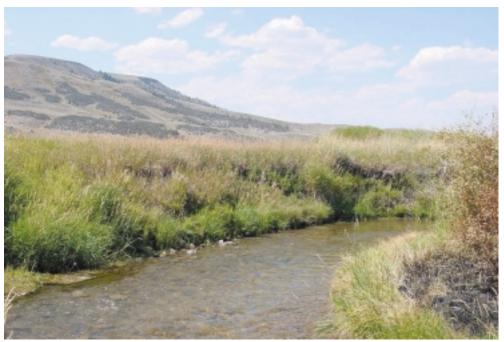
FIGURE 10 B Willow cuttings from a broader perspective.

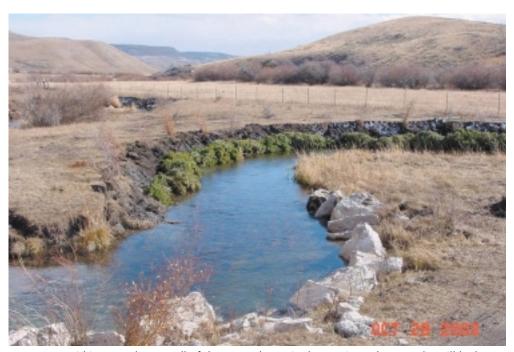
FIGURE 11 Within several years, all of the areas shown in the previous photographs will look as good and function as well as this section that was completed just two years ago.
